DRIVEABILITY OF COMPOSITE PILES

GUADES, E. J. *, ARAVINTHAN, T. & ISLAM, M. M.

* Centre of Excellence in Engineered Fibre Composites, Faculty of Engineering and Surveying, University of Southern Queensland,
Toowoomba, Australia

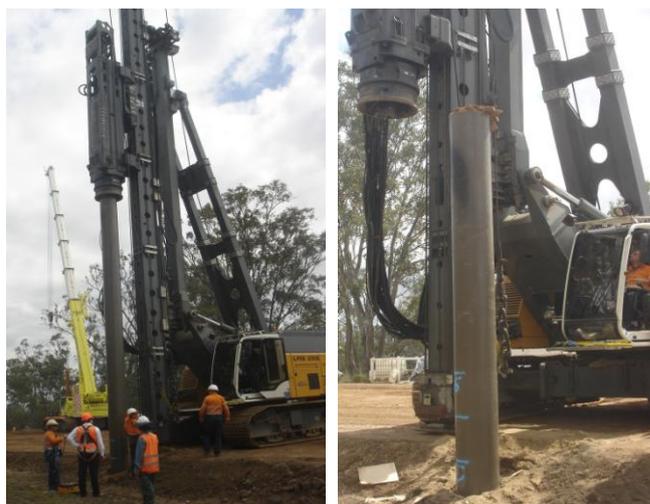
FIGURE 02: Pile driving rig for trial test.

Composite pile was also field-driven in an elevated walkway project located in Tweed Heads, Australia. This project utilized pultruded tubes that were manufactured by Wagners Composite Fibre Technology (WCFT) in supporting the superstructure. The tube was held by a steel frame and was driven by a 1ton diesel hammer as shown in Fig. 01. The 4m long pultruded tubes were driven to an embedment depth of 2.5 – 3.0m. Geometric and mechanical properties of the adopted tubes are given in the subsequent page. No geotechnical data was obtained on the site where the field tests were carried out.

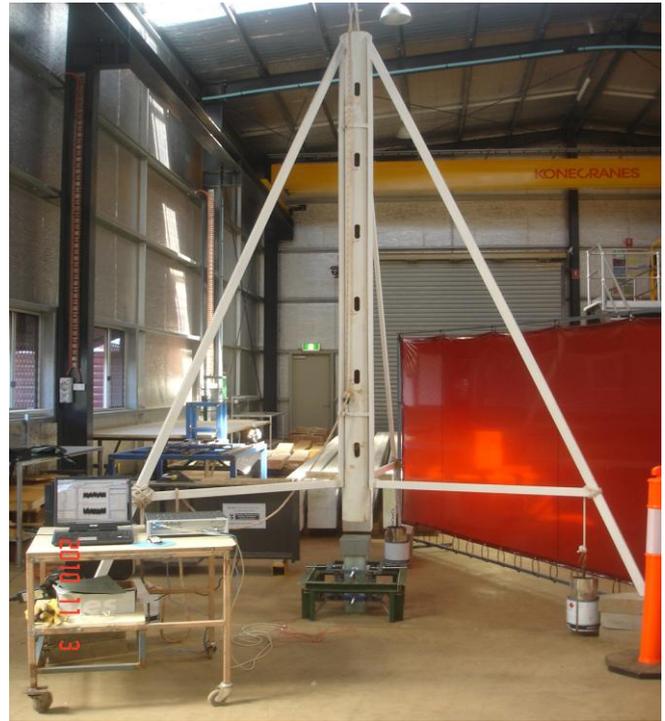
FIGURE 07: Testing set-up and drop impact test apparatus.

No standard was published to suit this type of set-up and test; however, impacting test apparatus under AS 4132.3 (1993) was adopted except some modification on the set-up of the specimen. The 500mm long tube was supported by a steel frame mounted on the solid base (i.e. concrete pavement). Testing set-up and impact apparatus are shown in Fig. 07. Impact test was performed using an un-instrumented free-fall-dart testing apparatus with a total mass impactor of 14.72 kg. The falling height of the testing apparatus is 3.2, 2.7, and 2.2 m, which corresponds to incident energies of 460, 390, and 318 J respectively. The section was impacted up to maximum impact cycles of 75 impacts. The specimen was instrumented with 2 uni-directional strain gages mounted on the mid-height of the pultruded section. This distance is normally sufficient, as it is away from the direct mass impact. An LMS data acquisition device and a personal computer were used to capture
