# Shear Strengthening of Cracked RC Beam Using External Post-tensioning

T.G. Suntharavadivel, Thiru Aravinthan and Steven Luther

*Faculty of Engineering & Surveying, University of Southern Queensland, Australia*

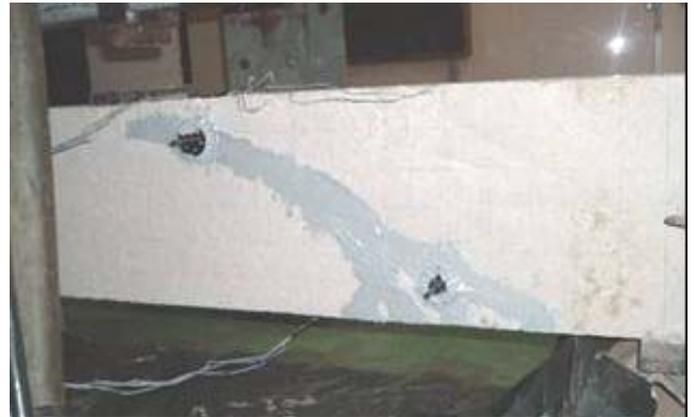
cracking and later strengthened by external post-tensioning and reloaded until the failure. The third specimen, RCB3, was also pre-loaded to cracking and these cracked were repaired using epoxy injection as shown in Figure 2. Then RCB3 was strengthened by external post-tensioning and loaded again until failure. The last beam, RCB4, was strengthened by external post-tensioning and tested under static loading. This simulated the condition of a new beam with external prestressing. The test variables are summarised in Table. 1.

Figure 2. Repaired shear crack using epoxy injection

The third specimen RCB3 was loaded the same way as RCB2 and observed similar progress in initial crack propagation. The cracks were repaired with epoxy injection and allowed for a week to cure the resin and to develop a good bond. Then the specimen was prestressed to 150 *kN*, similar to RCB2, and reloaded. An interesting result was observed in the crack propagation. A new shear crack was initiated that lead to failure of the beam (Figure 8). The repaired crack did not open-up again during the subsequent loading. This proved that the epoxy repair was properly done. Furthermore, it has increased the capacity of the member to 310 *kN*, 58%

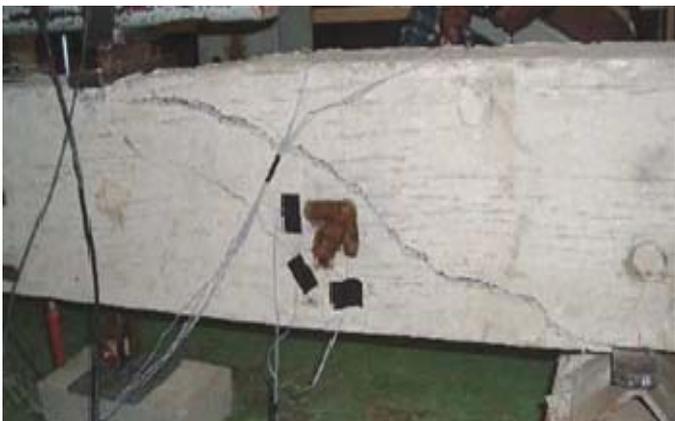
Initially, some flexural cracks were observed in bottom of mid span section in the control beam, RCB1. However, they did not develop further as the load was increased. The first shear crack appeared at 125 *kN* near the tension side at the support and progressed with further loading. The control beam could achieve 196 *kN* before it failed in shear. The load-deflection of RCB1 is shown in Figure 4. The formation of shear cracks reduced its stiffness, which is noticeable in the figure. The maximum crack width at failure was 2.5 *mm* (Figure 5).

Figure 5. Failure of the control beam, RCB1

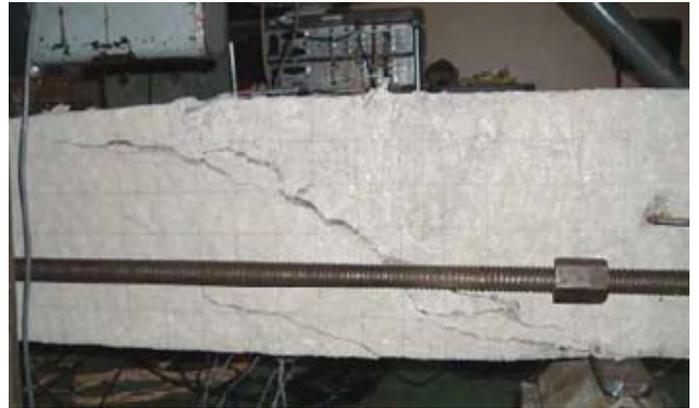
The second beam, RCB2, was initially loaded up to 90% of its capacity (about 180 *kN*) to simulate the initial cracks. The formation of cracks and its performance were very similar with RCB1. Then load was released for strengthening. After applying 152 *kN* prestress using external rods, the specimen was reloaded until failure. Even though high prestress was applied, the initial shear cracks were not fully closed with the application of external post-tensioning. The same cracks further widened and led to the failure during the second stage of loading, as shown in Figure 6. The failure occurred at 194 *kN*, slightly lower than the load on control beam. The load-deflection curve of RCB2 is shown in Figure 7. At the maximum load, the crack width was found to be 3 *mm* and it further increased to 8 *mm* at failure.

Figure 6. Failure of the control beam, RCB2

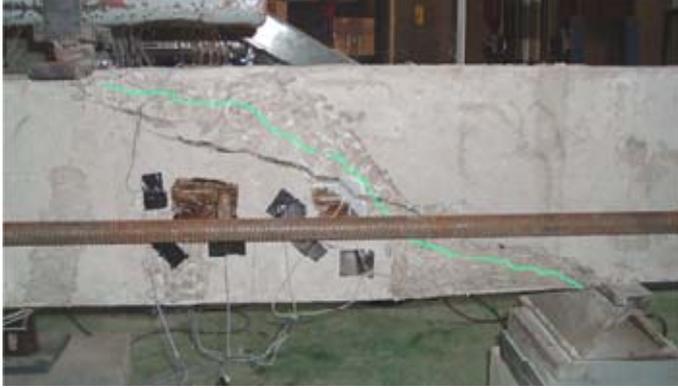
Figure 8. Failure of the control beam, RCB3 (initial crack is highlighted)
