IS EXTERNAL POST-TENSIONING AN EFFECTIVE SOLUTION FOR SHEAR STRENGTHENING OF BRIDGE ELEMENTS?

Thiru Aravinthan
University of Southern Queensland
Faculty of Engineering and Surveying
Toowoomba QLD 4350
Australia
aravinhant@usq.edu.au

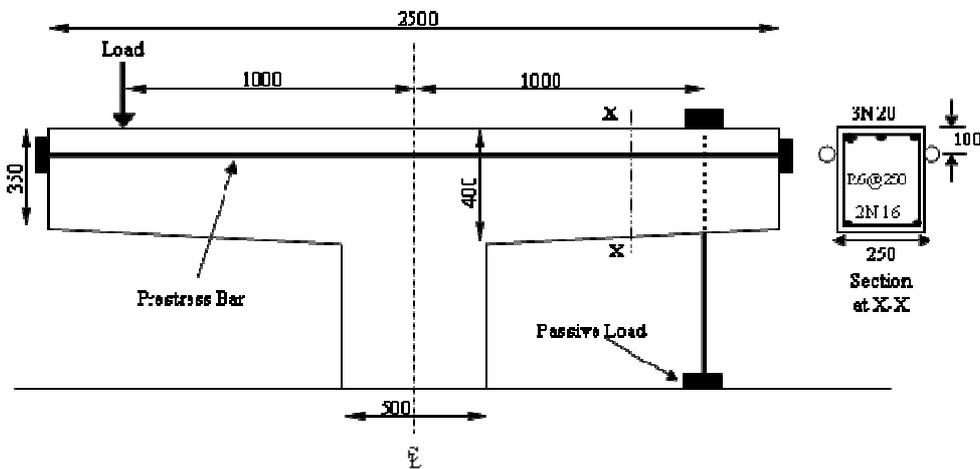
The preliminary experimental program consisted of three reinforced concrete cantilever headstock specimens (PRCS1, PRCS2 and PRCS3) with rectangular cross section throughout its length of 2500 mm. All specimens were tapered shape cantilevers with cross section of 350x250 mm at the toe end and 400x250 mm at the heel end of the specimen. Fig. 1 shows the typical reinforcement layout of the specimen. Sufficient flexural reinforcement was provided to ensure flexural failure is dominant.

Fig. 1 Typical layout of preliminary experimental specimen

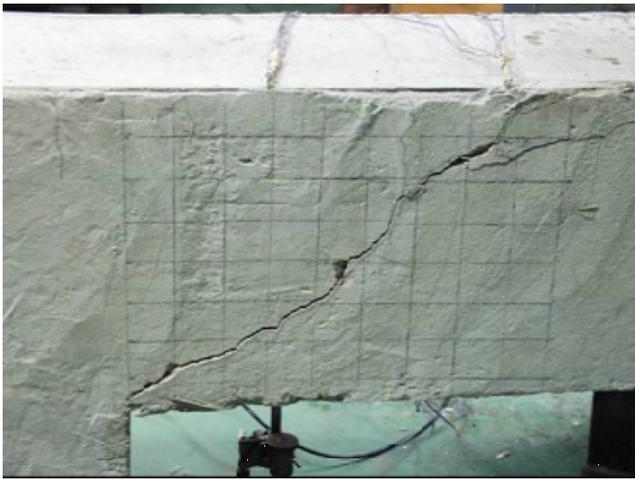
In the control specimen, PRCS1, initially small flexural cracks appeared near to support pier. However, these cracks did not open further during the test. The first shear crack was developed at about 100 kN load, near the point of loading and moved down at an angle approximately 45° towards the headstock-pier joint as shown in Fig.2. It was fully developed at 120 kN. Maximum crack width of 2 mm was observed at the ultimate load of about 150 kN and decreased to 1 mm when the specimen was unloaded. Similar behaviour was observed for other two specimens during initial loading.

Fig. 2 Shear cracks in control specimen

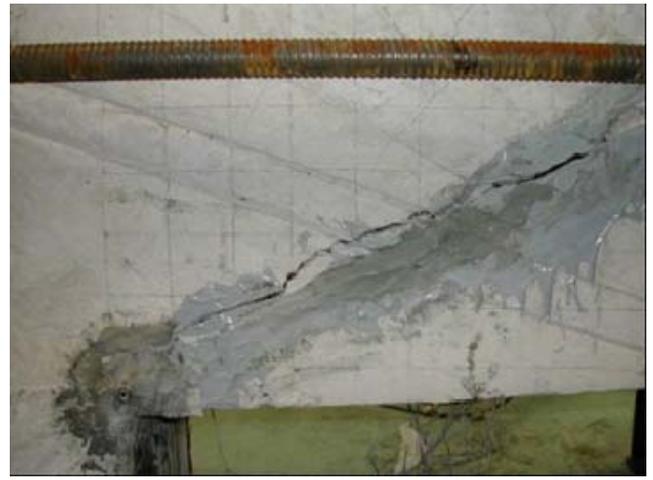
Fig. 3 Shear cracks in after the repair of shear cracks by epoxy injection

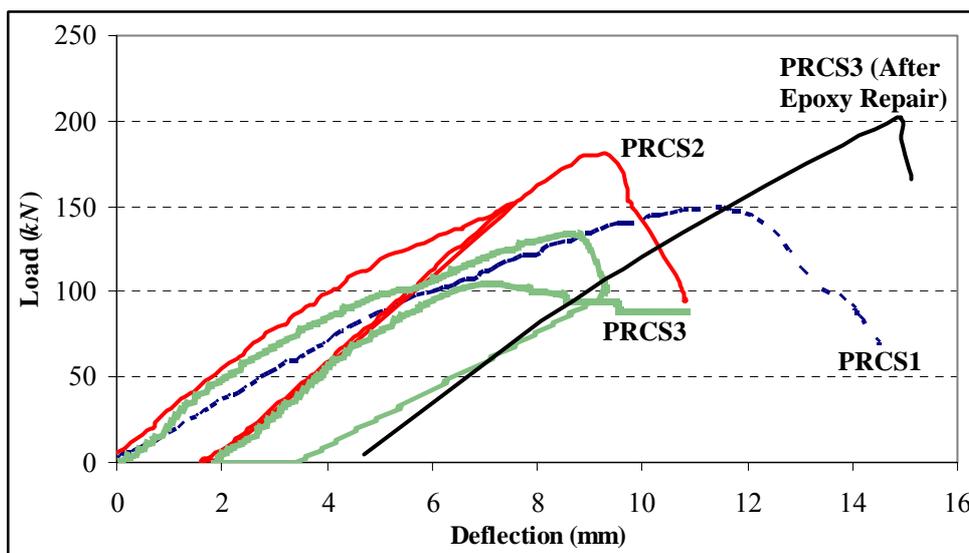
The load-deflection behaviour of the three specimens was shown in Fig. 4. The effect of the shear crack could be clearly observed in the figure. Furthermore, the epoxy injection did not change the stiffness of the specimen, but it significantly increased the capacity. That shows the epoxy injection could eliminate the effect of shear cracks and bring as a new beam.

Fig. 4 Load-deflection response of shear specimens

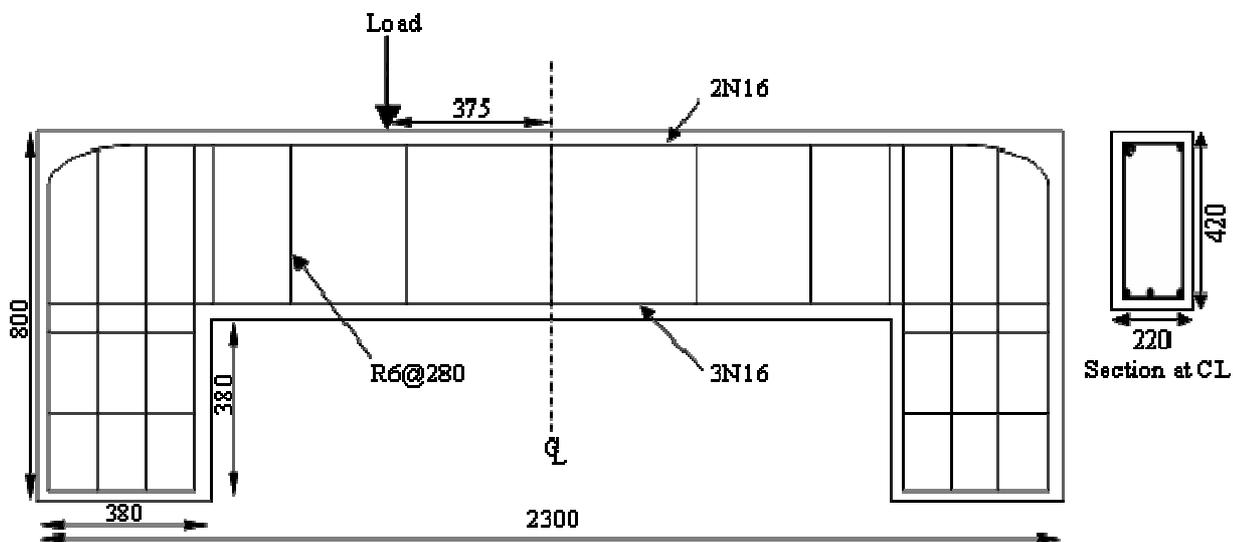
To verify the applicability of the external post-tensioning strengthening system, tests were conducted on $\frac{1}{4}$ scale model of the Tenthill Creek Bridge headstock. Three model specimens were tested with the test variables being repairing of crack and strengthening by prestressing. All three specimens were constructed with a uniform rectangular cross section of $420 \times 220 \text{ mm}$. Each specimen was 2300 mm long. Fig. 5 shows the typical layout of the specimen and reinforcement details. Though Y type bars have been used in the actual bridge, due to non-availability of such bars at the time of the experiment, N type ($f_{sy} = 500 \text{ MPa}$) bars were used. The area of steel was approximately scaled down to $1/16$ of the actual bridge to reflect the dimensional scaling.

Fig. 5 Typical layout of scaled model of Tenthill Creek Bridge headstock

Test variables of the specimens are summarised in Table 2. Loading was applied non-symmetrically as shown in Fig. 5 and 6, at a distance $\frac{2}{3}$ of span. This was based on the position of the main girder on the actual bridge that caused cracking in the headstock. The first specimen (control specimen) was loaded up to failure, without any strengthening. The other specimens were initially pre-loaded to cracking and later strengthened with external post tensioning. In the third specimen in addition to prestressing, cracks formed during the pre-loading were repaired by epoxy injection as shown in Fig. 7.

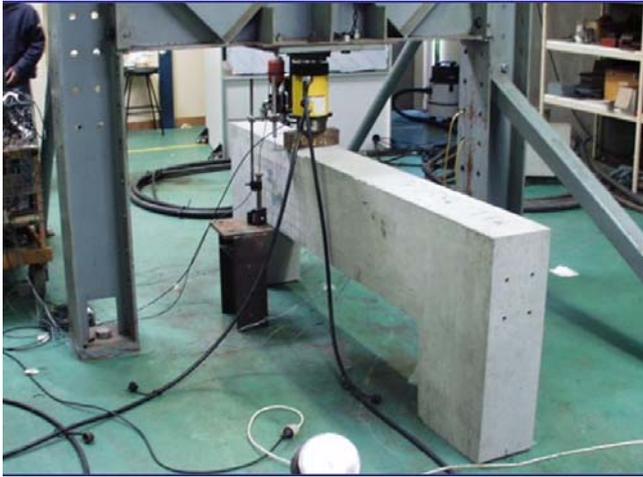
Fig. 6 Loading arrangement for the model test

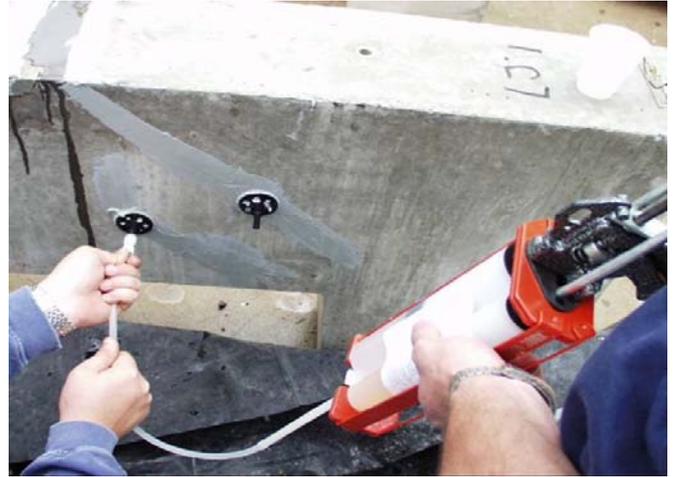
Fig. 7 Repair of shear crack by epoxy injection

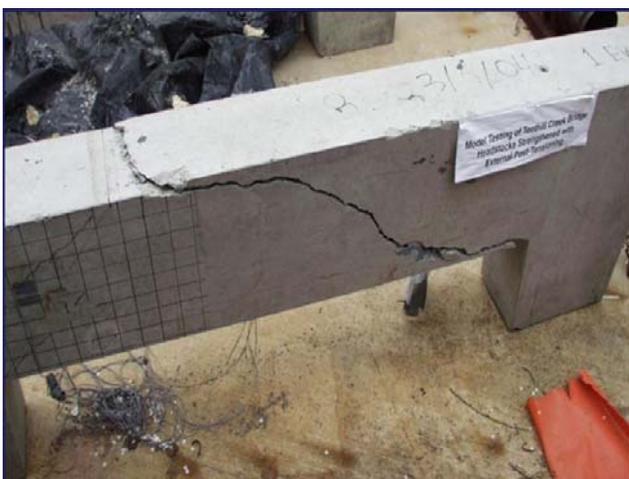
The second specimen THM2 was initially loaded to develop a shear crack. The behaviour and cracking during this initial loading were found as similar as THM1. After the specimen was post-tensioned with 250 kN , the major shear crack in the long span closed to 0.2 mm . Then the specimen was reloaded and almost immediately the same cracks began to reopen (Fig. 8a) and lead to fail. It was also interesting to note that while loading the crack in the short shear span also reopened. Once loading had ceased, the width of this crack was in the vicinity of 0.9 mm wide. Most of this deformation occurred shortly after loading commenced.

Fig. 8a Failure of headstock along the longer shear span (without epoxy repair)

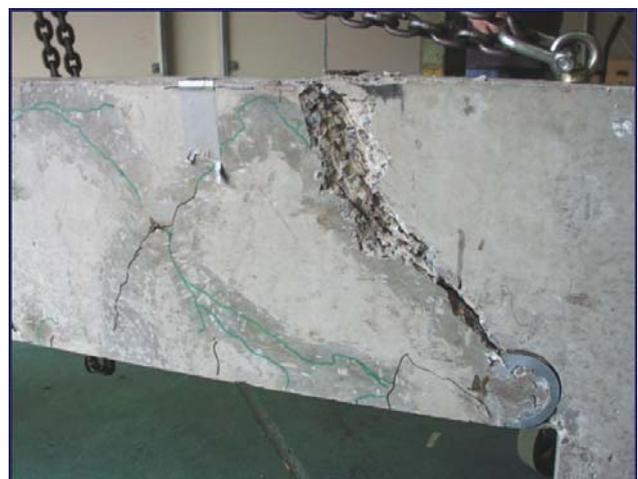
Fig. 8b Failure of headstock along the shorter shear span (with epoxy repair)

Specimen THM3 was also initially preloaded to produce the shear crack. The crack pattern that was produced during preloading was similar to that seen in specimens THM1 and THM2. Then specimen was unloaded and cracks were repaired by epoxy injection. At the same time, the failed specimen THM2 was also injected with epoxy resin. Once the resins were cured, the specimens were post-tensioned and loaded again. When loading was increased the initial crack in the short shear span appeared. However, as the load was increased, the crack continued to gradually open. The shear crack in the longer span did not develop during the test. Finally, the specimens failed through the crack at short shear span (Fig. 8b). It is evident that the epoxy injection was properly done and the injection process reformed the bond between the crack faces. The behaviour of both repaired specimens THM2 and THM3 was very similar even though the ultimate load of repaired THM2 was increased by 68%, while THM3 was increased by 46% as shown in Table 3.

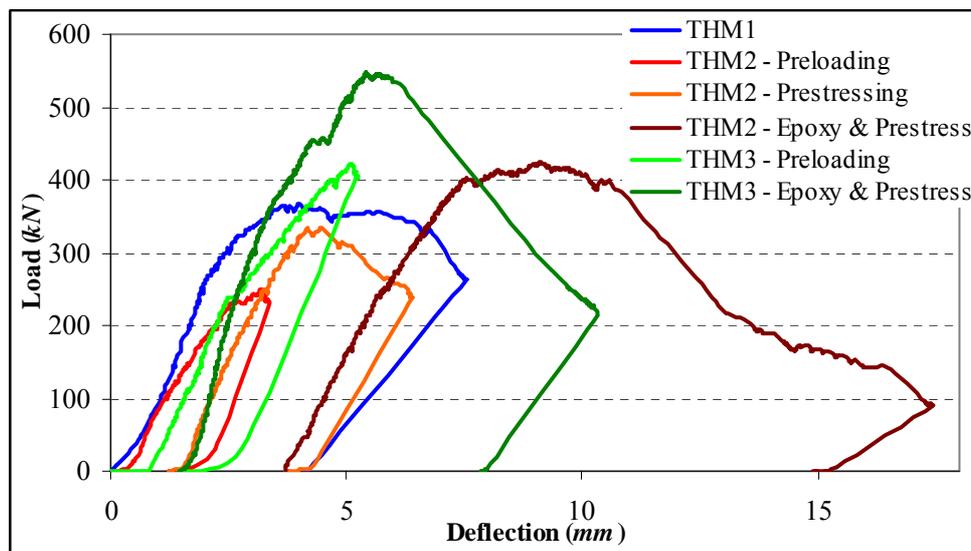
The load-deflection response of the model test is shown in Fig. 9. Once again, the effect of existing shear crack and the epoxy injection could be seen clearly. The test results are summarised in Table 3. Further details about the model test can be obtained from (Aravinthan & Heldt, 2005; Woods, 2004).

Fig. 9 Load-Deflection Response of Specimens

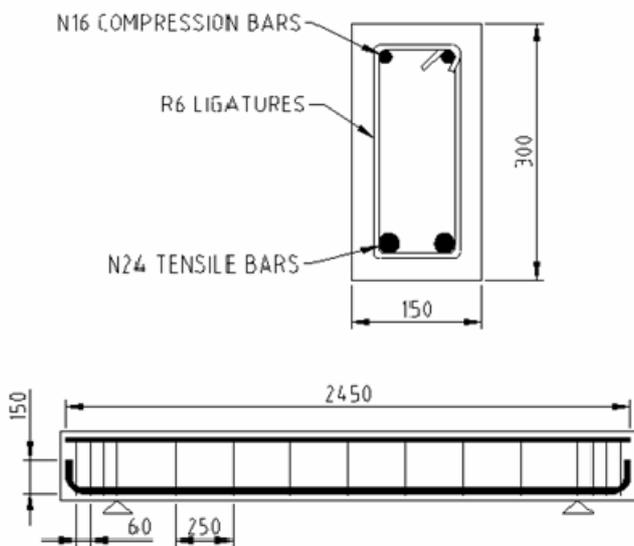
It was noted in the previous experiments the concrete strength could significantly affect the test results, especially when estimating the shear strength. Therefore, additional tests were carried out using model beams. These results were further investigated by testing a set of reinforced concrete beams with symmetric loading. For this purpose, four reinforced concrete beams with rectangular cross section of 300x150 mm were constructed. Each beam was 2500 mm long. For shear reinforcement, R6 bars were provided at 250 mm spacing in the shear span and at 100 mm near to the ends. Fig. 10a shows the typical reinforcement layout of the experimental models. The effective span of the beam was set 2000 mm. Four-point loading was applied with the shear span 750 mm (Fig. 10b). In this experiment all four beams were prepared at the same time and were cured under the same conditions to make sure that the concrete strength was nearly the same. The test variables are summarised in Table 4. Totally, 150 kN force was applied through the external rods (about 75 kN in each).

Fig. 10a Typical layout of the beam

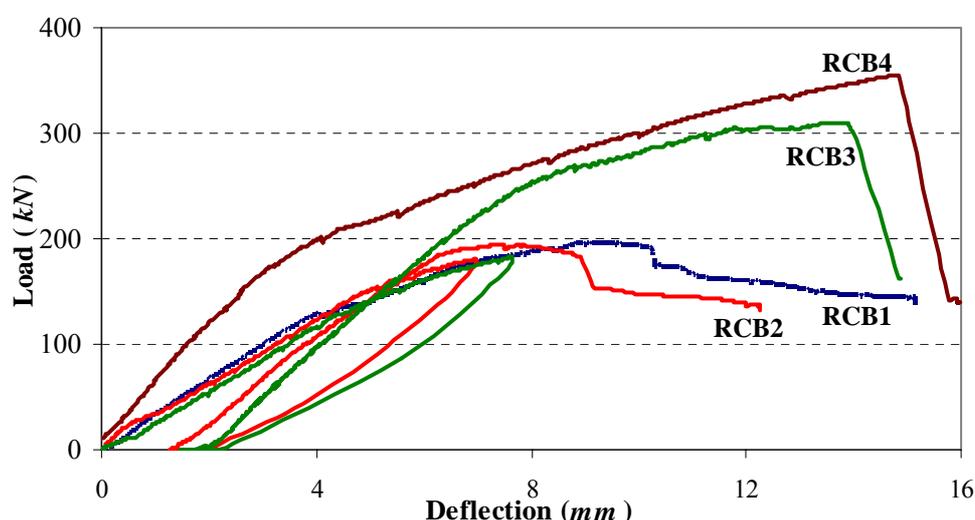
Very similar behaviour was observed as earliest experiments in the crack formation. The flexural cracks, which appeared in early stage of loading, did not develop further as the load was increased. The member capacity of the control beam was found as 196 kN. The maximum crack width at failure was 2.5 mm. The other two beams, RCB2 and RCB3, were initially loaded up to 90% of its capacity (about 180 kN) to simulate the initial cracks. The RCB2 failed at a load of 194 kN, slightly lower than the load on control beam. At the maximum load, the crack width was found as 3 mm and it further increased to 8 mm at failure. In the epoxy repaired specimen, RCB3, the repaired crack did not open-up again during the subsequent loading, which is very similar to the model test of the Tenthill Creek Bridge headstock. This proved that the epoxy repair was properly done. Furthermore, it has increased the capacity of the member to 310 kN, nearly 60% increment of control beam. At the maximum load, the crack width was found as 3

mm and it was 7 mm at failure. The last beam, RCB4, was tested to obtain the effect of external post-tensioning in the uncracked reinforced concrete beam. The beam could achieve ultimate load of 354 kN before it failed in shear. The failure mode of RCB4 was similar to the failure mode of RCB3, which can be noticed in Fig. 11. The ultimate loads of each specimen are tabulated in Table 5. It clearly shows that without repair the shear crack can significantly reduce the efficiency of the strengthening by external post-tensioning. The properly repaired and post-tensioned beam had similar behaviour with the uncracked beam strengthened by external post-tensioning. Further details about the on the experiment is reported by Luther (Luther, 2005).

Fig. 11 Load-Deflection Response of RC Beam Specimens

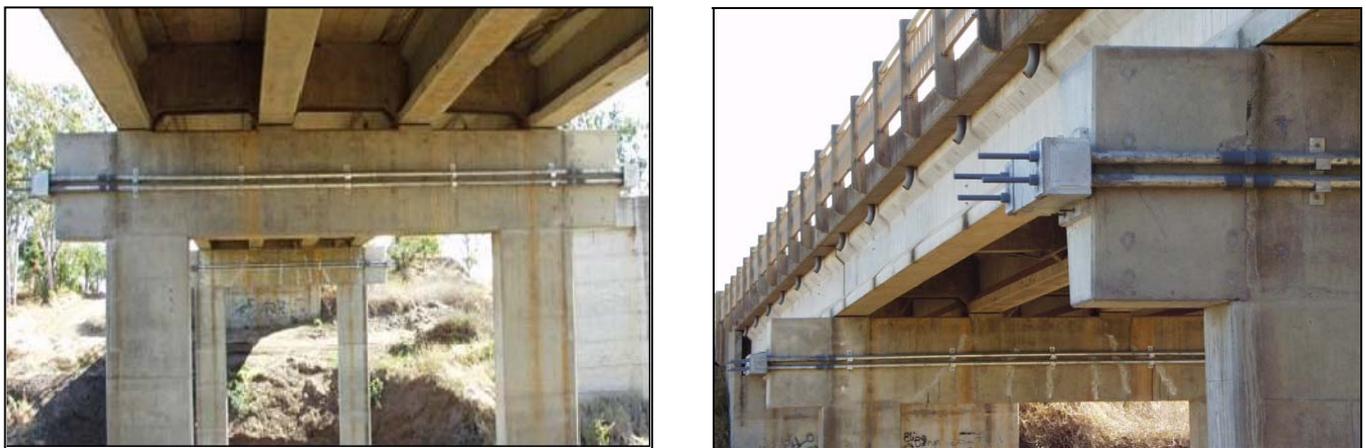
The Queensland Department of Main Roads has recently upgraded the headstocks of the Tenthill Creek Bridge with the conventional external post tensioning. Fig. 12 shows the Tenthill Creek bridge headstocks after strengthened by external post-tensioning. It can be seen that the existing cracks have been repaired by epoxy injection. In this particular bridge, the external post-tensioning was provided using high strength prestressing steel rods. These rods were protected from corrosion by providing an encasement that has been grouted.

Fig. 12 Strengthened headstocks of Tenthill Creek Bridge by external post-tensioning
