Fault Tree Analysis Method for Deterioration of Timber Bridges using an Australian case study

This paper identifies common causes for timber bridge deterioration and demonstrates an integrated approach based on fault tree analysis (FTA) to obtain qualitative or quantitative estimation of the risk of failure of timber bridge sub-systems. Level 2 inspection report for a timber bridge in Queensland, Australia has been utilized as a case study in this research to identify the failure modes of the bridge.

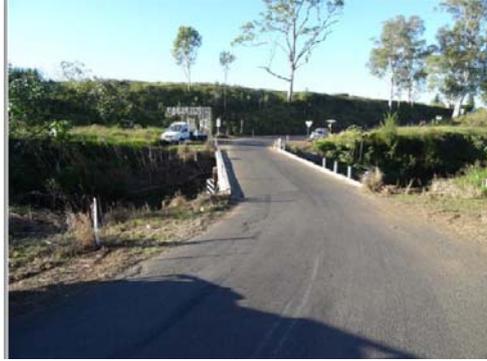
Figure 1: Middleton's Bridge

Strategies for the selection of a case study has been researched in the past (Flyvbjerg 2006). It is important to select a critical case study which gives the information needed to complete at least one sub tree of the fault tree diagram for timber bridges. From the several timber bridge inspection records, the selected case study is the Middleton's Bridge crossing Lockyer Creek on the Lockrose Road North in Lockyer Valley Regional Council area in Queensland, Australia (Figure 1). It is a two span, single lane timber Girder Bridge with an overall length of 19.35 m, a width of 5.48 m and a load limit of 35 tons. The superstructure was made up of hardwood timber curb and hardwood timber deck planks installed transversely, supported by five timber girders, corbels at the piers and two timber headstocks at the abutments and pier. The substructure is made up of four timber piles and eight timber wales/bracings. The bridge is about 20 degrees skew to the road alignment. Both approaches are bitumen sealed.

The analysis is based on a Level 2 inspection report conducted as per Queensland Main Roads Bridge Inspection Manual (MainRoads-Queensland 2004). The main reason for the selection of this case study is that, in Level 2 inspection report, it was identified that there are defects in some timber components, the most serious being the splitting in timber superstructure girders. The inspection report recommended that the defective timber elements be replaced. It also recommended that if the bridge is to remain open for public until the members are replaced, there should be load restrictions enforced to the use of the bridge. Hence LVRC commissioned another company to carry out a Level 3 inspection to recommend suitable load restrictions for the bridge.

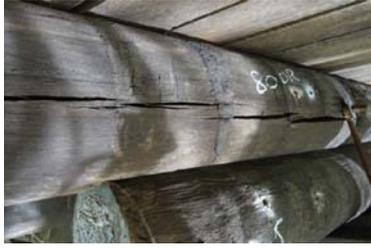
(a) Splitting (girder with a fastener)

The condition of each element of the bridge is rated using four condition states where condition state 1 is the best and condition state 4 is the worst (MainRoads-Queensland 2004). Figure 2 shows some selected photos to demonstrate the failure modes of structural members of this bridge.

Out of all different types of deterioration for the case study timber bridge, splitting and snipping of girders is the most common mode (Figure 2 and Table 1). It can be due to various events such as shrinkage of green timber element, changed cross section and snipping initiated due to notches and fasteners and spread due to overloading. Figure 5 illustrates the fault tree for the splitting of timber bridge stringers.

This research mainly focuses on the deterioration of timber bridge elements due to splitting as it was the main cause of failure for the major structural elements in the superstructure as well as sub structure of the case study timber bridge. Most of the girders in the case study bridge (6 out of 10 total in both spans) were given a replacement decision due to severe splitting at ends. Installing anti-splitting bolts were recommended for all the four piles in order to cater for severe/moderate vertical splitting. Both the headstocks were recommended to be replaced due to the fact that they had severe to moderate horizontal splitting which extended to the pile interface connection. However, the framework is demonstrated using assumed probabilities for basic events.

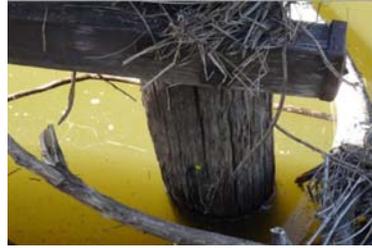
(b) Vertical splitting (pile)

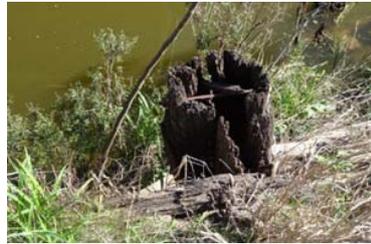
(c) Severe rot and pipe (wingwall pile)

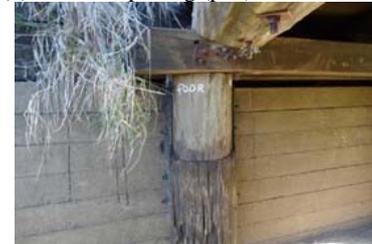
(d) Incorrect splice (abutment)

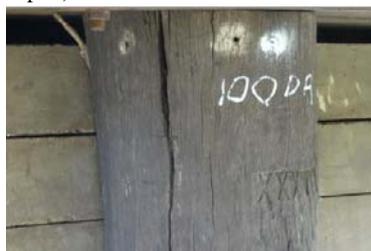
(e) Vertical splitting (overloading-top of pile)

Abrupt sectional changes (associated with notches) can cause unnecessary stress concentration that leads to defects in structural members. Abrupt changes in girders near connection may also lead to splitting if imposed shear force or combination of shear and bending at the cross section exceeds the acceptable level (VicRoads 2006). Notches can develop splitting and snipping that lead to a failure of the structural element. Queensland timber bridge maintenance manual (MainRoads-Queensland 2004) recommends 1: 5 gradient at the notch. Girders and corbels in old timber bridges can suffer from structural splitting or snipping due to overloading from higher axel loads than the design loads (Wilkinson et al. 2005). These snipping can be vertical, horizontal, or slanted.

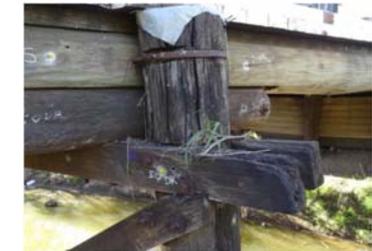
(f) Vertical splitting (changed section-top of pile)

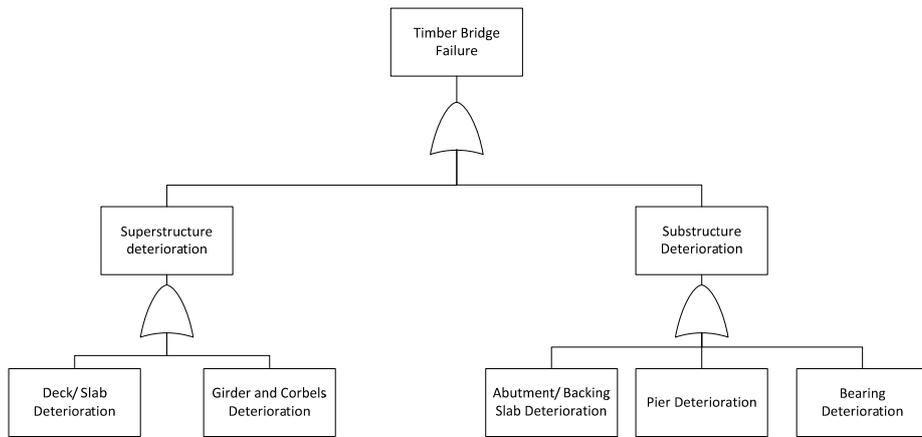
Figure 3: Top level fault tree frame

Based on the observations from the case study bridge (Table 1, 2 and Figure 2) and the available literature (Austroads 2009; Bootle 1983; Mainroads 2014), the top level of a fault tree diagram for a timber bridge was developed as shown in Figure 3. The main event, timber bridge failure can be triggered because of either the superstructure or substructure deterioration. Each of the basic events is connected to the main event using OR gate because the output event occurs if any one of the input events occurs.

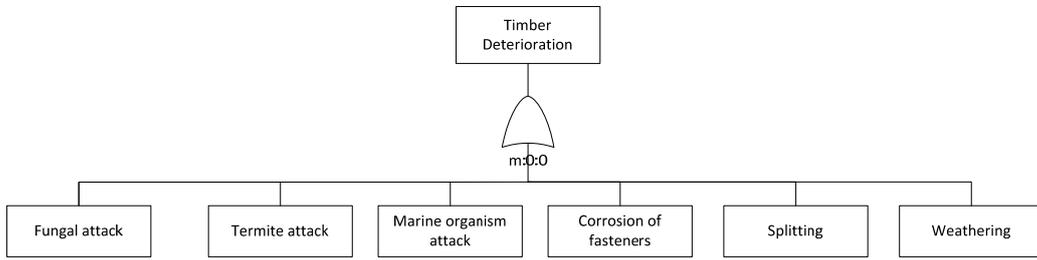
Figure 4: Major sub system fault tree of timber deterioration

There are many causes for timber deterioration as shown in Figure 4. One or many factors/events can contribute to the deterioration of timber as explained before. It is important to understand the probability of occurrence of each event to predict main event, 'timber deterioration' reliably. Therefore a voting gate which is capable of representing the combination of inputs to trigger the output has been used in this part of the FTA. For example out of the 6 intermediate events in Figure 4, if 2 events occur then the leading event will also occur.

Similar approach can be used to establish the probability of failure due to other causes such as fungal attack, termite attack etc in Figure 4. If the probability of these causes is assumed to be equal to that of splitting (0.00299) then if timber deterioration occurs when 2 out of 6 causes occur, then the probability of timber deterioration can be calculated as, $P = 1 - (1 - 0.00299^2)^6 = 0.0000536$. This is the probability for timber deterioration in Figure 4. The bottom events of Figure 3 are all related to timber deterioration though these values may differ from one another. If it is assumed to be the same as 0.0000536, then the probability of substructure and superstructure damage will be 0.00016079 and 0.00010728 respectively. Hence the probability of failure of the bridge will be 0.000268.

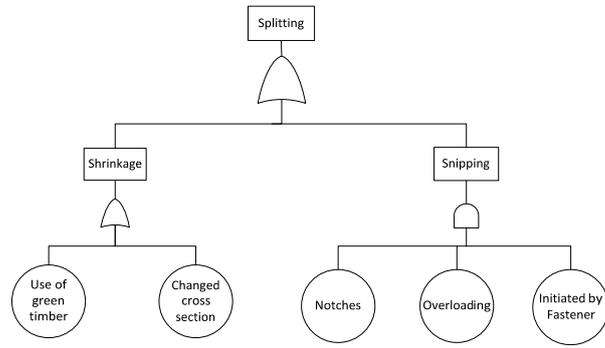
Figure 5: Fault tree for Splitting Failure

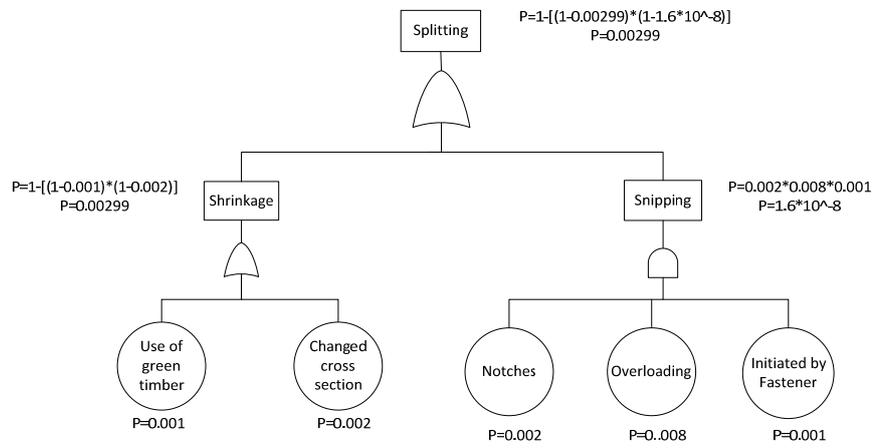
Figure 6: Application of the method for splitting branch of FTA

Splitting branch of the FTA for timber bridge deterioration is demonstrated using assumed probabilities for basic events (Figure 6). For example, it was assumed that the probability of having a changed cross section for a member is 0.002 and that for using a green timber is 0.001. Either the use of green timber or changed cross section will lead to shrinkage. Hence an OR gate (Equation 2) is used to link these 2 basic event to the shrinkage. The same approach was used to find the snipping probability (Equation 1) and ultimate probability of splitting (Equation 2) to be 0.00299 (Figure 6). This is the probability that can be used for splitting in Figure 4.
