# Analysis of Flood Impact on Reinforced Concrete (Pre-stressed) Girder Bridges – a Case Study

F. Kalendher, S. Setunge, & H. Mohseni  
*RMIT University, Melbourne, Australia*

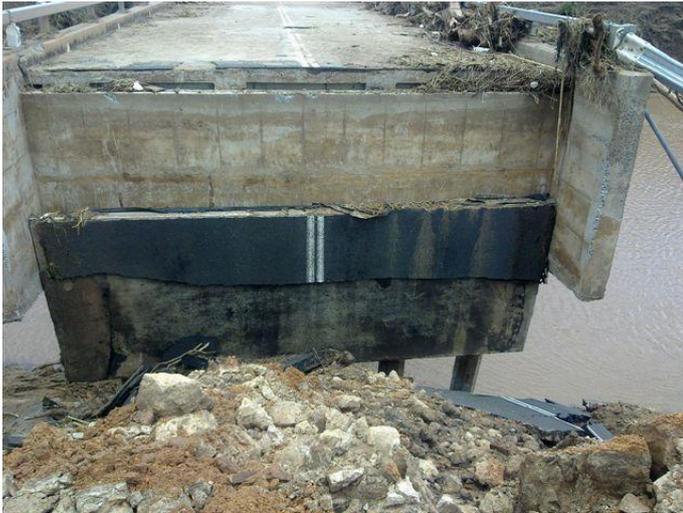
Bridge could be damaged in many ways when it is under an extreme flood event (Farook et al., 2014). If the bridge is completely inundated during the flood, the damage to the bridge depends on the length of time it was submerged as well as the types of debris collected around or passing the bridge components. Extra care should be taken to inspect the supports of the bridges, even after the flood water recedes. Approaches of a bridge could be damaged due to debris impact, settlement or depressions. Debris against substructure and superstructure, bank erosion and damage to scour protection will damage the waterways. Bridge substructure could fail due to movement of abutments, wing walls, piers, rotation of piers and missing, damaged dislodged or poorly seating of the bearings while the superstructure could fail due to the debris on deck, rotation of deck, dipping of deck over piers or damage of girders. It is identified that urban debris such as cars; containers etc. and the insufficient bridge span to through that debris were the main cause for damaging bridges aftermath of 2011/2012 extreme flood events in Queensland (Pritchard, 2013). Fig. 1 depicts the damaged Kapernicks Bridge from Lockyer Valley

Region in Queensland, which is the case study covered in this paper.

Fig 1: Damaged Kapernicks Bridge in Lockyer Valley Region in Queensland, Australia

ected bridges before they were open for traffic. A bridge inspection report was compiled by Lockyer Valley Regional Council for 46 affected bridges in the region. Detailed analysis of these bridges revealed that different bridges failed due different failure mechanisms. It also revealed that some of the bridges failed mainly because of unusual floating debris such as shipping containers, cars and river-craft (for example 300t vessels). This paper investigates the impact of a floating container on Kapernicks Bridge in the case study area together with other flood induced forces.
