EFFECTS OF EXISTING SHEAR DAMAGE ON EXTERNALLY POST TENSIONED REPAIR OF BENT CAPS

Thiru Aravinthan¹, M.ASCE, P.E., and T.G. Suntharavadivel²

ABSTRACT

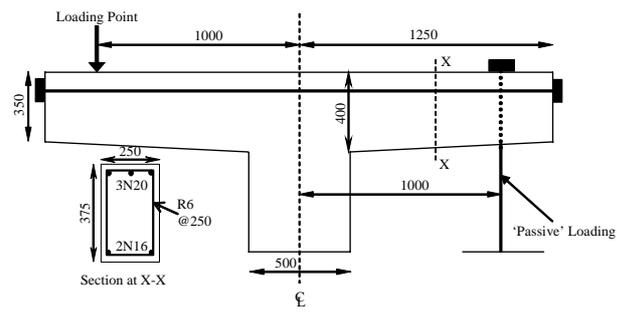
Fig. 1. Typical Layout of Initial Test Specimen

The experimental program involved three reinforced concrete cantilever bent cap specimens with rectangular cross sections throughout the whole length of 2500 mm. All specimens were of tapered shape cantilevers with cross sections of 350x250 mm at the toe end and 400x250 mm at the heel end as shown in Fig. 1. Sufficient longitudinal reinforcement was provided to ensure that the specimens fail in shear. The test parameters are summarized in the Table 1. With available loading facilities, the specimens were loaded on one end of the cantilever, while the other end was anchored to a strong floor, thus providing a 'passive load'. The distance between the loading point and anchoring point was 2000 mm. Fig. 2 shows the typical experimental setup and loading arrangement. The specimens were loaded by displacement control method using the actuator. The loading was applied until shear cracks developed in the bent cap. After cracking, the loading of control specimen RCS1 was continued to failure, while specimens RCS2 and RCS3 were unloaded. These two specimens were then externally prestressed by 150 kN and 300 kN, respectively. These specimens were reloaded further until the shear crack expanded substantially to the point where the specimens could not take any more load. Two load cells were attached to the end of each prestressing rod to measure the changes in the prestress force.

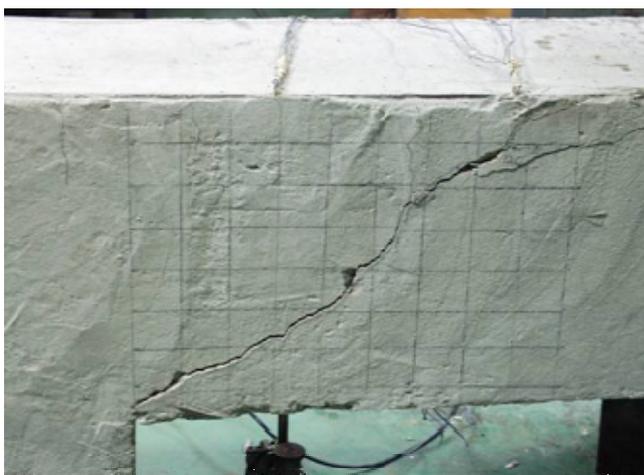
Fig. 3. Shear Cracks in the Control Specimen RCS1

In the control specimen, RCS1, initially small flexural cracks appeared on the tension zone near the column face. However, these cracks did not open further during the test. At about 100 *kN* load, a shear crack started to develop at the point of loading and moved down at an angle approximately 45° towards the bent cap-pier joint (Fig.3). It was fully developed at 120 *kN* load. Maximum crack width observed was 2 *mm* at the ultimate load of 149 *kN* but decreased to 1 *mm* when the specimen was unloaded. Similar behavior was observed for other two specimens in the preloading stage. After the application of 150 *kN* external prestressing to the specimen RCS2, the crack width was reduced to 0.5 *mm*. The same crack was re-opened during the reloading of this specimen. The specimen accepted a load of 180 *kN* before failure. The strength increase is about 20% higher compared with that of the un-strengthened beam.

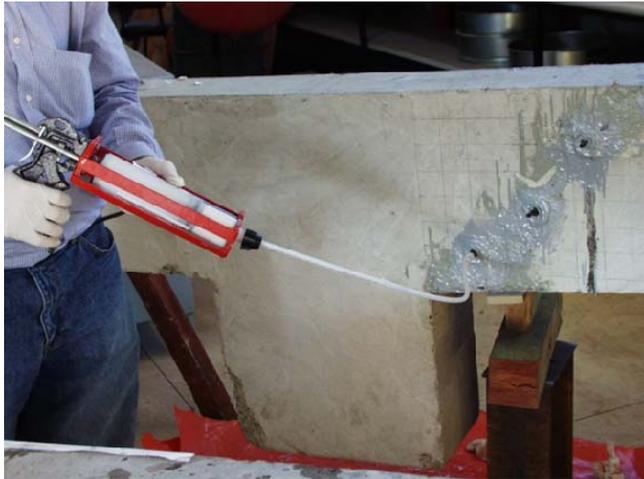
Fig. 4. Repair of the Shear Crack by Epoxy Injection

In a further attempt to strengthen this specimen, an epoxy treatment was used to repair the shear cracks as shown in Fig. 4. Initially, the cracks were sealed by a two part structural epoxy adhesive (Lokset E). After two days, a low viscosity epoxy (Nitofill LV) was injected through injecting points provided along the cracks (see Fig. 4). The low viscosity epoxy is capable of repairing cracks as small as 0.2 *mm* wide at the surface tapering internally down to 0.01 *mm* wide. The epoxy resin was injected from the lower part of the crack to ensure the crack was properly filled with the resin. The epoxy repair method has been detailed elsewhere (Wood 2004). After curing of the epoxy, 295 *kN* prestressing force was reapplied and the specimen was re-tested to failure. A new shear crack with a slightly flatter angle developed in the specimen above the repaired crack as shown in Fig. 5. This is an effect of the change in principle stress direction due to the axial force induced by the external post-tensioning. The maximum load during the re-testing was 201 *kN*, which is 49% higher than the maximum load applied during the pre-loading stage.

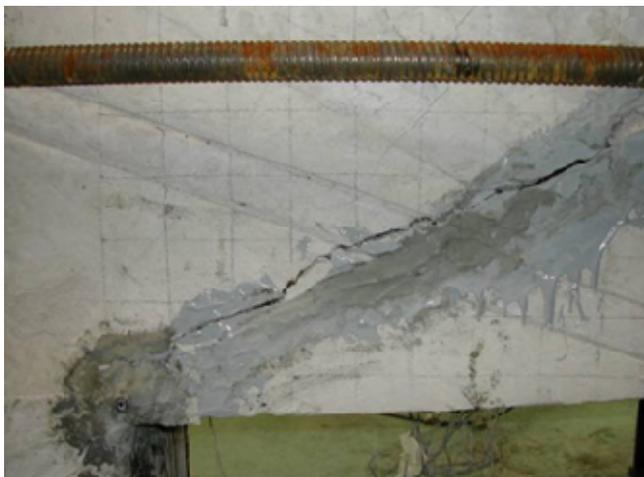
Fig. 5. New Shear Cracks in RCS3 after Crack Repair

The behavior of the third specimen RCS3 was expected to be similar, with much higher strength increase due to the increase in initial prestress to 296 *kN*, which is almost double the amount of that used in RCS2. However, the response observed for the specimen RCS3 was very different to that of RCS2. The specimen RCS3 was initially loaded until 135 *kN*, where an approximately 2 *mm* wide shear crack was created. Even though it was strengthened with 296 *kN* external post-tensioning, the crack width closed up to approximately 1 *mm*, still quite a large crack for the amount of prestress applied. The maximum load that could be applied after post-tensioning was only 105 *kN* load, which is lower than the maximum load achieved during the pre-loading stage. The same crack expanded and opened up to approximately 2.5 *mm* width during the re-loading stage. This means that, a significant reduction (-15%) in the member capacity resulted even after strengthening by external post-tensioning. What was also observed was the considerable deflection at the loading point of the cracked section due to the applied load. Noting that the width of the shear crack was still large (1 *mm*) after prestressing, the additional prestress force was in fact counterproductive, creating larger cracks when loaded again.

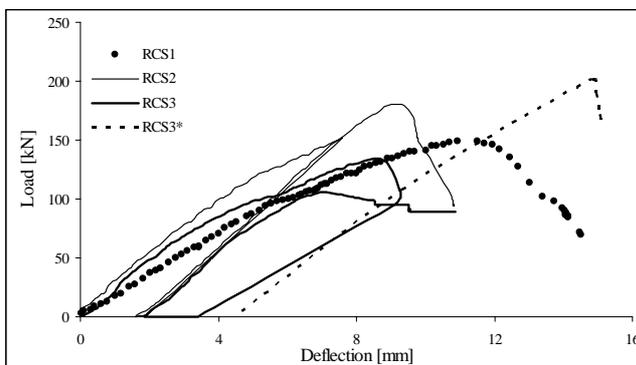
Fig. 6. Load-Deflection Response of Initial Tests

The load-displacement behavior of all the three specimens is depicted in Fig. 6 and results summarized in Table 1. From Fig 6, it can be noted that the epoxy injection does not change the stiffness of the specimen, but it significantly increases the capacity. It is also important to note the change in the prestress force after strengthening as shown in Fig. 7. In specimen RCS2, this force increased from 150 *kN* to 195 *kN*, which is 30% higher than the initial prestress. For specimen RCS3 without repairing of cracks, the increase was only marginal, varying from 296 *kN* to 307 *kN*. However, the increase was substantial from 295 *kN* to 362 *kN* after repairing the cracks in specimen RCS3, which is denoted as RCS3* in Table 1, Fig. 6 and Fig. 7. It could be noted that when the cracks were not repaired, there is no apparent increase in the prestress force up to a deflection of about 2 *mm*. Only at larger deflections, specimens RCS2 and RCS3 showed some increase in the prestress force. This non-increase in RCS2 and RCS3 can be attributed to the possible slip along the inclined shear cracks. At larger deflections, the prestress force is increasing due to increase in chord distance of the prestressing bars. However, in specimen RCS3* there is gradual increase in the prestress force, which indicates that the epoxy injection has been effective in preventing the possible slippage at the cracked plane.

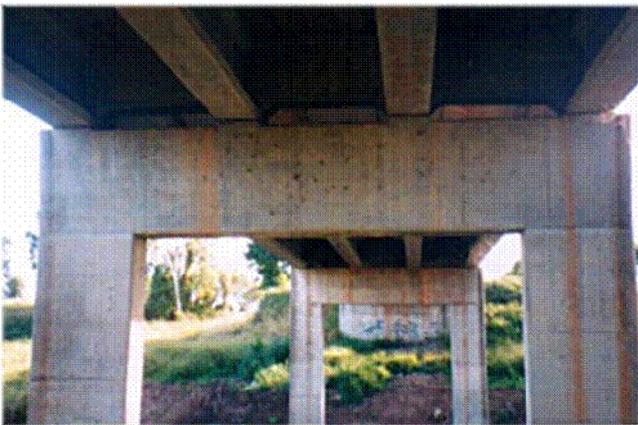
Fig. 8a. View of Tenthill Creek Bridge Bent Caps

A few bridges in Australia have been strengthened by external post-tensioning technology and one such example is the strengthening of the bent caps of Tenthill Creek Bridge (Fig. 8a). Heavy loading on this bridge had caused some substantial shear cracking in the bent caps as shown in Fig. 8b. The crack extends from the edge of the pier to the location of the main girder on top of the bent cap and was approximately 1600 mm long and 0.5 mm wide. After analyzing the condition of the bent caps, the Queensland Department of Main Roads decided to strengthen the bent caps using external post-tensioning.

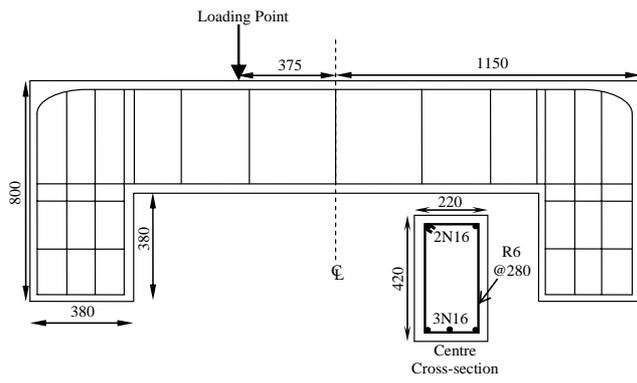
Fig. 9. Typical Layout of Model Test Specimen

To verify the applicability of the proposed strengthening system, tests were conducted on 1/4 scale model of the Tenthill Creek Bridge bent cap. The experimental program consisted of three specimens with rectangular cross sections of 420x150 mm throughout the whole length of 2300 mm. Though Y type bars (yield strength $f_{sy} = 400$ MPa) have been used in the actual bridge, due to non-availability of such bars at the time of this investigation, N type bars (yield strength $f_{sy} = 500$ MPa) were used. The area of steel was approximately scaled down to 1/16 of the actual bridge to reflect the dimensional scaling. N16 bars were used as main reinforcements while shear reinforcements were provided by R6 bars (mild steel; yield strength, $f_{sy} = 250$ MPa). The reinforcement details of the specimens are shown in Fig. 9.

Loading was applied asymmetrically at a distance of 375 mm from the center of the specimen as shown in Fig. 9. This was based on the position of the main girder in the actual bridge that caused cracks in the bent caps. The first specimen (control specimen, RCH1) was tested under static loading up to failure, without any strengthening. The other two specimens (RCH2 and RCH3) were initially pre-loaded to cracking and later strengthened using external post-tensioning. Before prestressing, cracks formed during the pre-loading stage were repaired in the third specimen (RCH3) by injecting epoxy resin similar to specimen RCS3 in the initial investigation. The test parameters are summarized in the Table 2. The shear cracks in specimen RCH2 was further repaired after failure, by epoxy injection and retested, whose results are reported as RCH2*. As the specimens were constructed

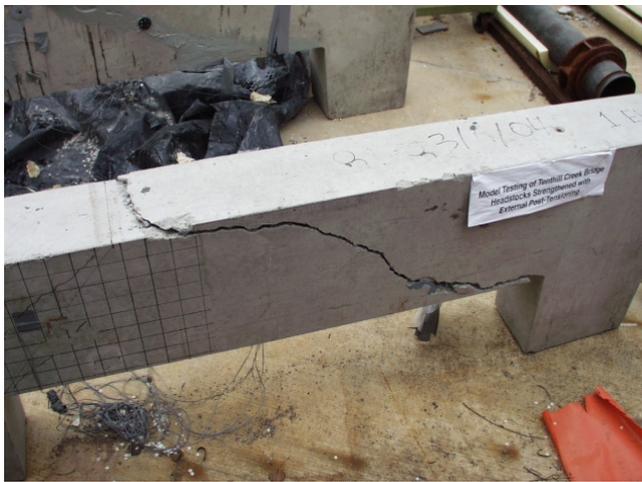
Fig. 10. Failure of the Control Specimen RCH1

An interesting crack pattern was observed in the control specimen, RCH1 when loaded. Small flexural cracks appeared early in the loading stage, at about 80 *kN* load. However, these cracks did not propagate further when shear cracks began to develop. At a load of about 125 *kN*, a shear crack developed in the shorter shear span which was very similar to the shape of the crack found in the actual bridge. However, as the load was increased further to about 230 *kN*, a completely new shear crack developed in the longer shear span. The specimen failed when the load reached 366 *kN*, with the shear crack on longer shear span widening further to about 4 *mm*, as shown in Fig. 10, in a diagonal tension failure mode.

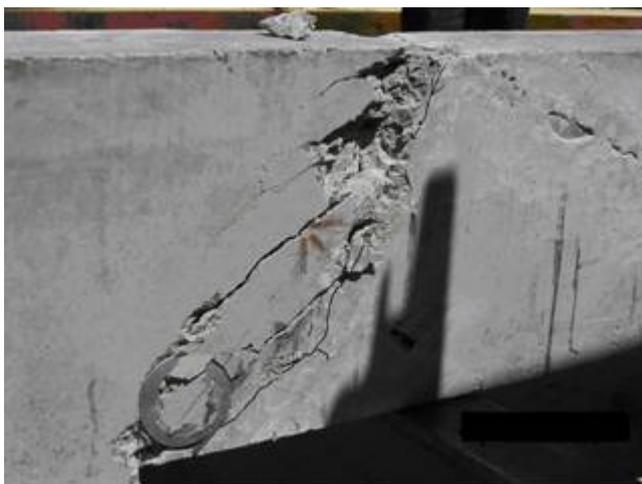
Fig. 11. Failure of RCH2* (after epoxy injection)

Specimen RCH3 was also preloaded as RCH2 to produce the shear cracks, which were very similar to the other two specimens. The specimen RCH3 was unloaded and cracks were repaired by epoxy injection. During this time, the failed specimen RCH2 was also injected with epoxy resin. Post-tensioning was introduced after curing of epoxy resins and the specimens were reloaded. As expected, an initial crack appeared in the short shear span when reloaded. Unlike RCH2, as the loading was increased further, the crack on the shorter shear span continued to become wider. The shear cracks that were repaired in the longer shear span region, did not reopen in the subsequent loading. Finally, the specimens failed in a shear compression mode with very large inclined crack in the shorter shear span that was different to the original crack during preloading as shown in Fig. 11. Crushing of concrete was also observed near the loading point. Both specimens showed very similar behavior after repairing with epoxy resin, even though the ultimate loads were different for the two specimens. The test results are summarized in Table 2.

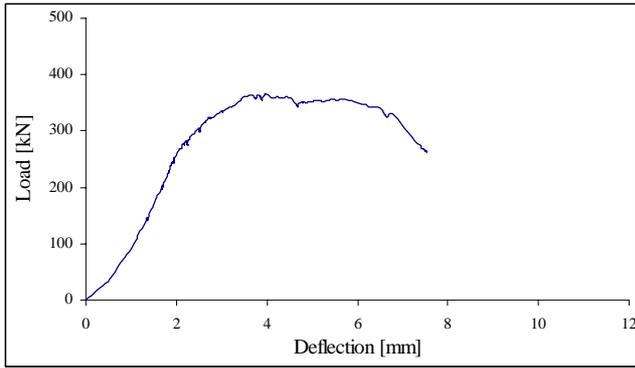
Fig. 12. Load – Deflection Response of Specimen RCH1

The load-displacement characteristics of the specimens are given in Figs. 12 to 14. The behavior of RCH1 is nearly linear during the initial stage of loading (Fig. 12). The development of crack could be identified from the graph by small dips from about 150 kN load. Between 250 kN and 300 kN, a number of these dips are evident and the slope of the plot begins to decrease. This corresponds to the stage at which major cracks began to appear in the longer shear span section. The load-deflection response of the second specimen, RCH2, is shown in Fig. 13. An increase in the capacity can be seen as each restoration technique has been applied to the specimen. After post-tensioning, the RCH2 accepted a maximum load of 333 kN, which is 33% higher than the preloading stage. Once the cracks were repaired by epoxy injection, the same specimen could take a load as high as 420 kN, which is 68% higher than the load at preloading stage. By comparing the three linear regions in the plots for specimen RCH2, slight changes in the stiffness of the member are evident. An increase in the member's stiffness can be seen after the application of post-tensioning as would be expected. However, the increase in stiffness after epoxy injection is only marginal in specimen RCH2*.

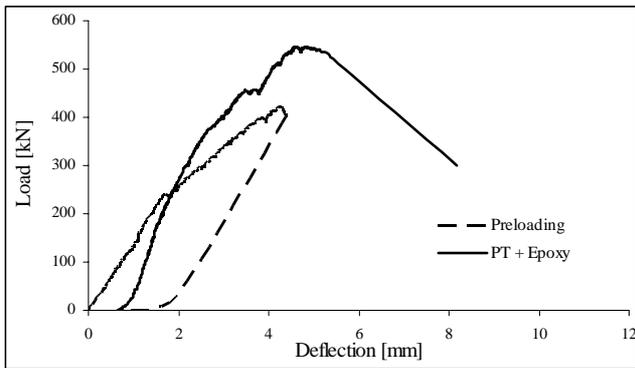
Fig. 14. Load – Deflection Response of Specimen RCH3

From the plot of third specimen, RCH3 (Fig. 14), it can be seen that the specimen had to be preloaded up to a load of 423 kN to obtain the same crack width as in RCH2. The higher loading is attributed to the much higher concrete strength in specimen RCH3 compared to that of RCH2. Once the specimen was injected with epoxy and post-tensioned, the maximum load was increased to 546 kN. This increase is only 29%, which is much less compared to specimen RCH2*. This could be attributed to the difference in strengths of concrete in these two specimens. A substantial decrease in load is evident subsequent to the specimen reaching its peak load. This is

explained by the breaking of one of the stirrups passing through the shear crack. It can also be seen that in specimen RCH3, a large increase in stiffness after the specimen was rehabilitated compared with RCH2*. This may be attributed to the crack width filled with epoxy. When this crack width is large, the increase in stiffness is relatively low (as in RCH2*) compared to the case of RCH3 where a smaller crack width is filled with epoxy.

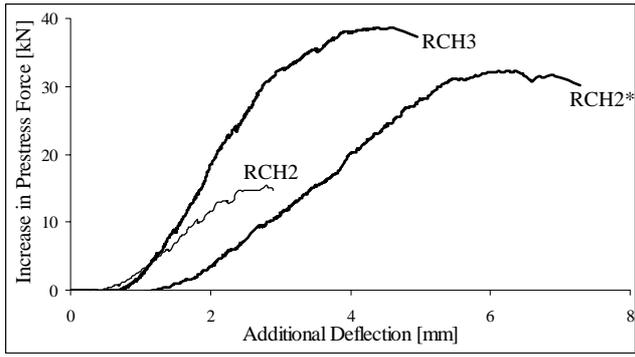
Fig.15. Variation of Prestress Force for Model Tests

The effect of the epoxy repair can also be seen in the changes in prestress force as shown in Fig. 15. Similar to the initial test results, the increase in prestress force in specimen RCH2 is only marginal, when cracks were not repaired. However, there was a significant increase in the prestress force in the specimen RCH2* and RCH3 when the cracks were repaired by epoxy injection. This non-increase in RCH2 can again be attributed to the possible slip along the crack plan, as explained in initial experimental results. Hence, it can be concluded that the repair of existing cracks is essential for strengthening by external post-tensioning to be effective and epoxy injection is a suitable technique to repair cracks in concrete specimens. This finding supports the test results reported by Pantelides et al, where epoxy injection of cracks were done for bent caps retrofitted with fiber reinforced polymer (FRP) composites over the cracked region for shear strengthening (Pantelides 2001). This also shows that retrofitting by FRP composites are possible as an alternative to external post-tensioning for strengthening of bent caps.
